Stony Brook Salt Marsh and Fish Passage Restoration
(20 acres, 3,000 feet)

Project 1. Stony Brook Salt Marsh and Fish Passage Restoration, Stony Brook component.

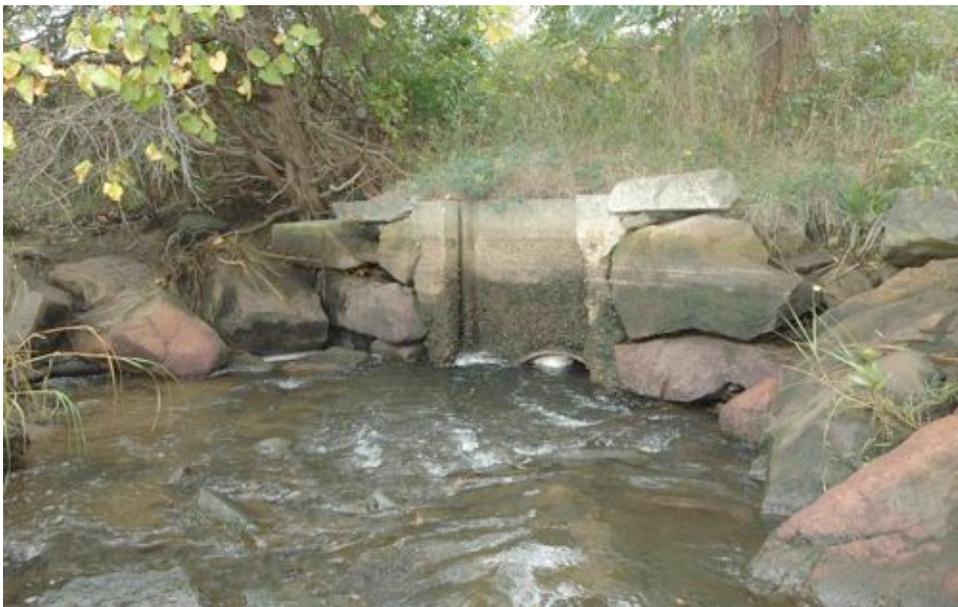
Figure 3. Stony Brook tidal culvert before restoration. South (restricted) side. 2010. The culvert is 4 feet in diameter (outside diameter).

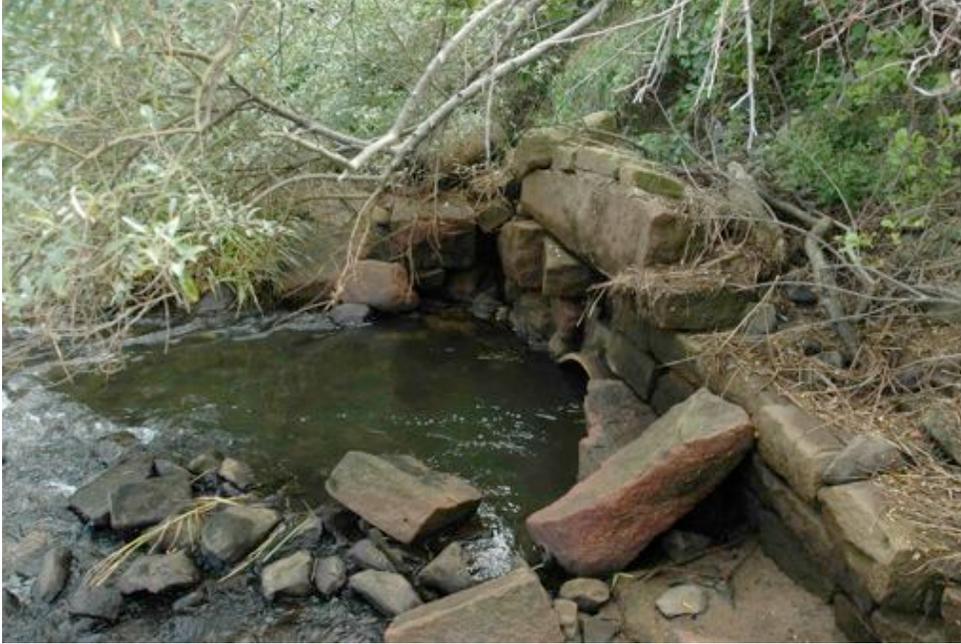
Figure 4. Stony Brook tidal culvert before restoration. North (unrestricted) side. 2006.

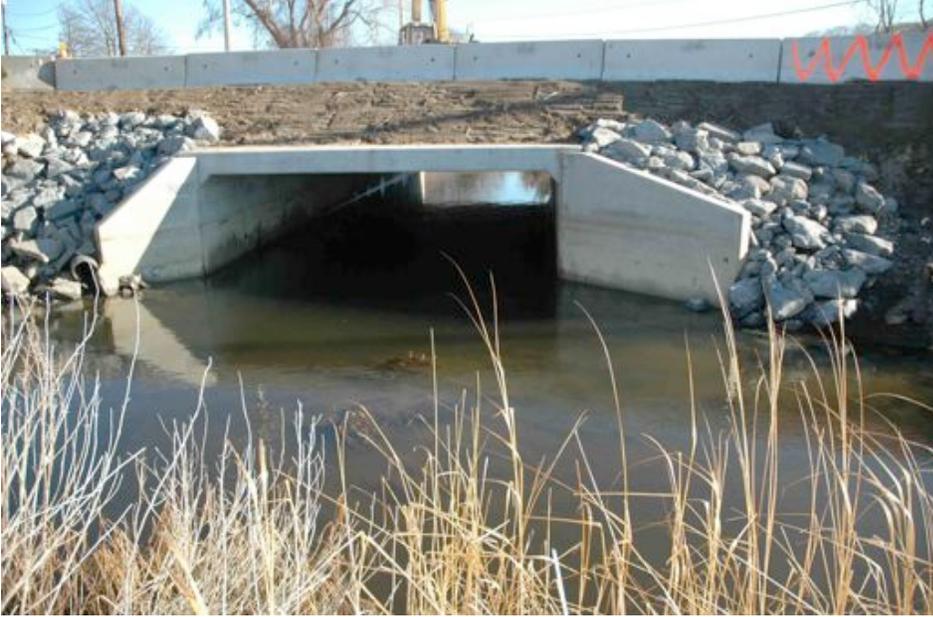
Figure 8. Stony Brook tidal culvert following restoration. North (unrestricted) side. The culvert is now 18 feet in diameter. December 2010.

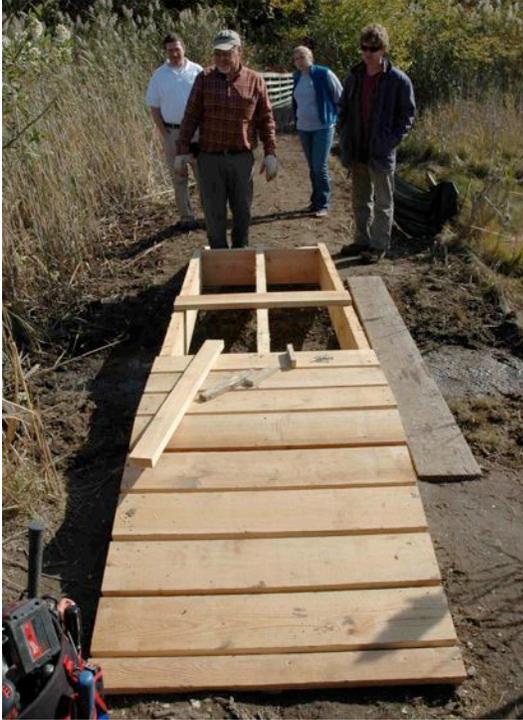
Figure 10. Improvements being made in marsh trail to increase tidal flow over the marsh at Stony Brook. November 2010. The trail was located on a low berm that served to impede tidal flow across the marsh. By removing sections of the berm and providing small footbridges, tidal flow across the marsh was improved. Construction work on the trail was done by Green & Robinson, Inc. of Kingston, Rhode Island.

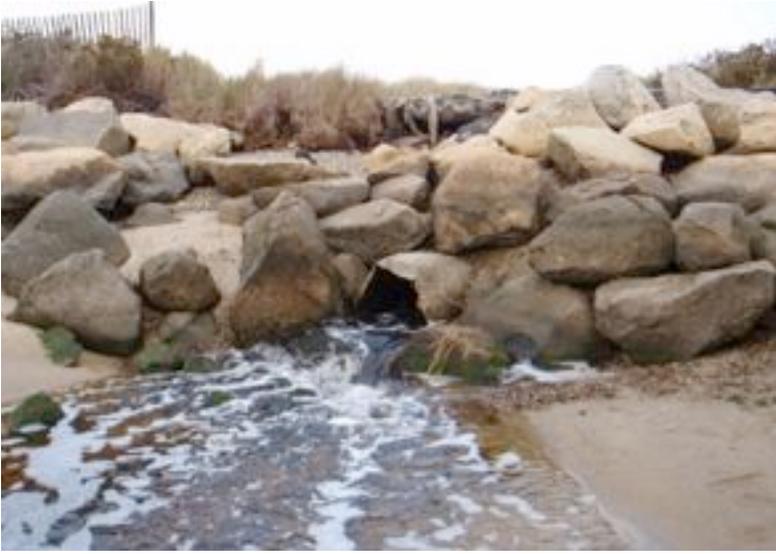
Figure 14. Seaward side of Freeman's Pond tidal culvert prior to restoration. The 3'-wide culvert, which is damaged, discharges into Paines Creek near Paines Creek Beach, a barrier beach on Cape Cod Bay. 2006.

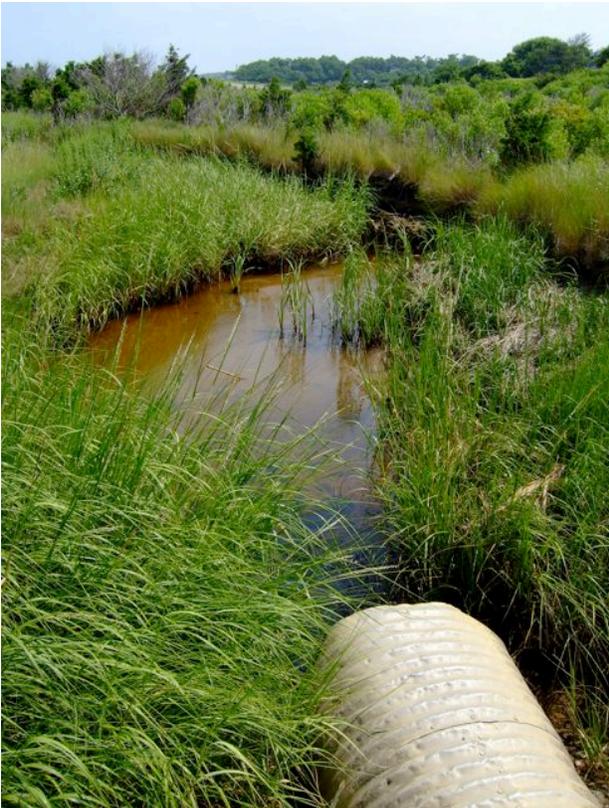
Figure 15. Restricted side of Freeman's Pond culvert prior to restoration.

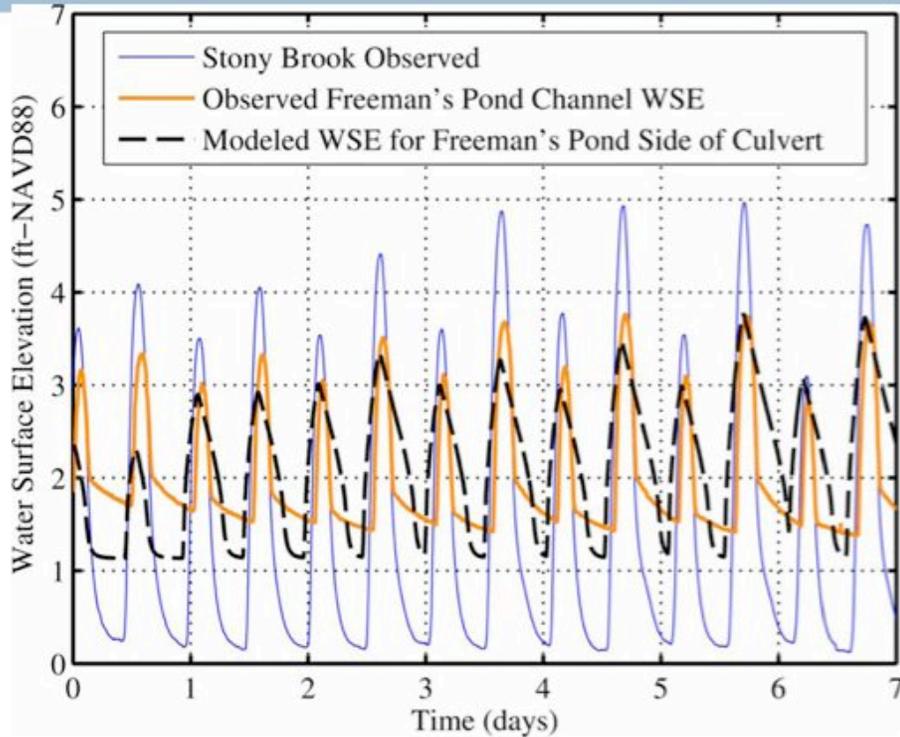
Figure 16. Tidal hydrograph of Freeman's Pond tributary channel compared to Stony Brook, which is the main estuary. The observed water surface elevation for the Freeman's Pond channel (orange) is lower than that of Stony Brook (blue) because the culvert restricts tidal flow. The restoration objective is to increase tidal flow and restore salt marsh by replacing the 3' culvert with a 10' culvert.

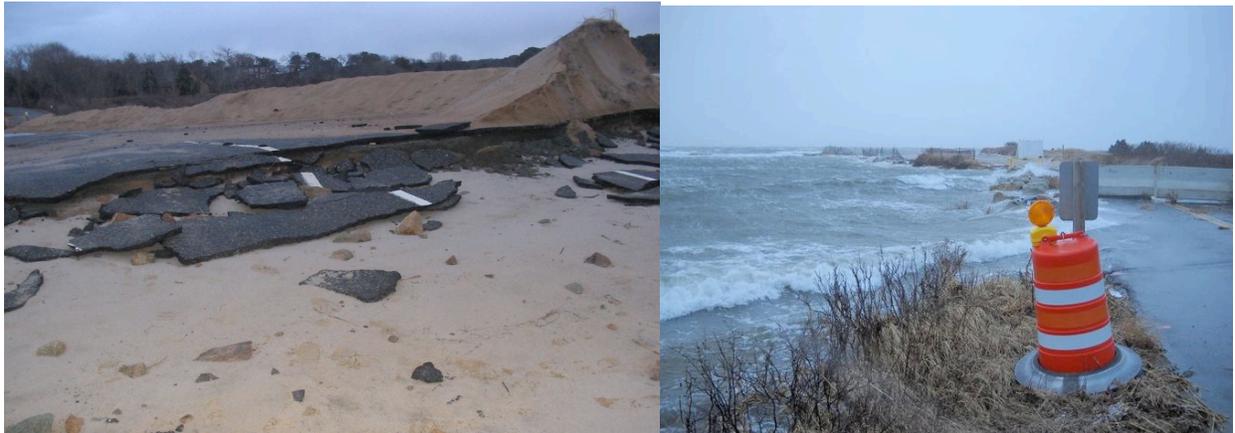
Figure 17. Paines Creek Beach parking area in the winters of 2009-2010 and 2010-2011. The parking lot was repeatedly demolished by winter storms and by 2011 the north end of the parking lot was gone. In 2011, the parking area was abandoned and removed. The area will be restored to a beach. This area is located adjacent to the tidal culvert at Freeman’s Pond and stormwater improvements at Paines Creek Beach.

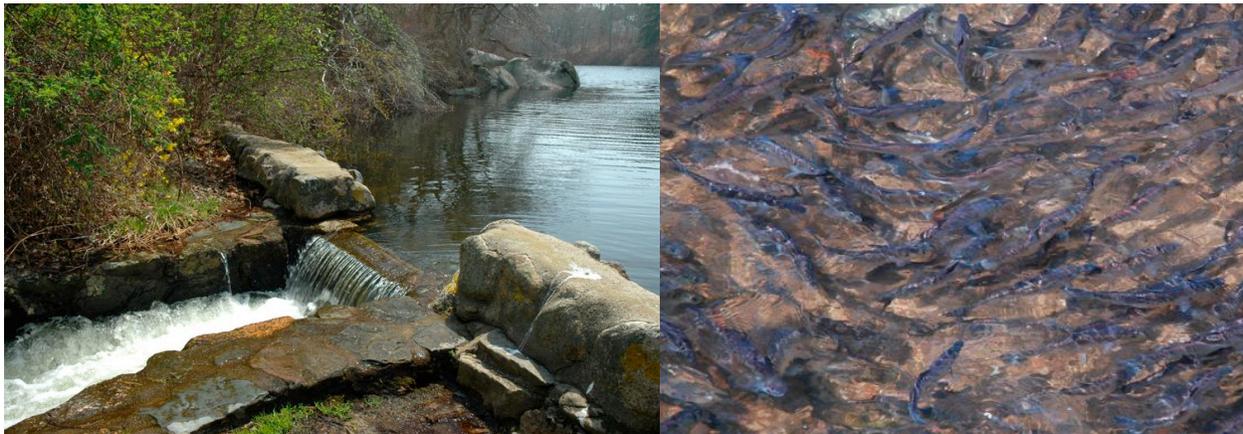
Figure 18. Lower Mill Pond Dam and fish ladder before restoration. The state Office of Dam Safety determined that the dam was failing. Lower Mill Pond is the first of five headwater ponds that provide 386 acres of spawning habitat for river herring and feeding and nursery habitat for American eels. Above, right, a sea gull waits during the annual spring herring run.

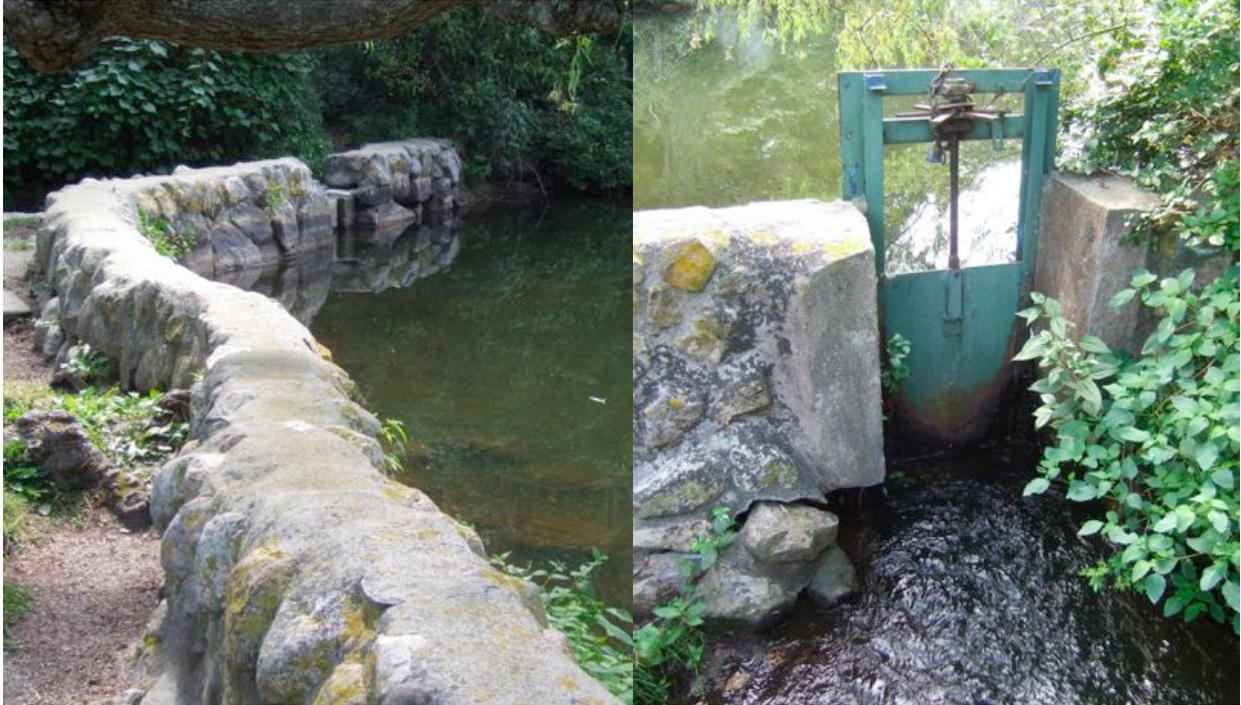
Figure 19. Lower Mill Pond Dam. A failing water control structure is shown at right. The water control structure is in need of repair and non-functional. Both the water control structure and dam are needed to maintain safe water levels in Lower Mill Pond and four other ponds in the watershed that together provide 386 acres of habitat for river herring, American eels and other fish and wildlife. The Town commenced engineering design and permitting as of August 1, 2011.
