Stony Brook Salt Marsh and Fish Passage Restoration
(20 acres, 3,000 feet)

Project 1. Stony Brook Salt Marsh and Fish Passage Restoration, Stony Brook component.

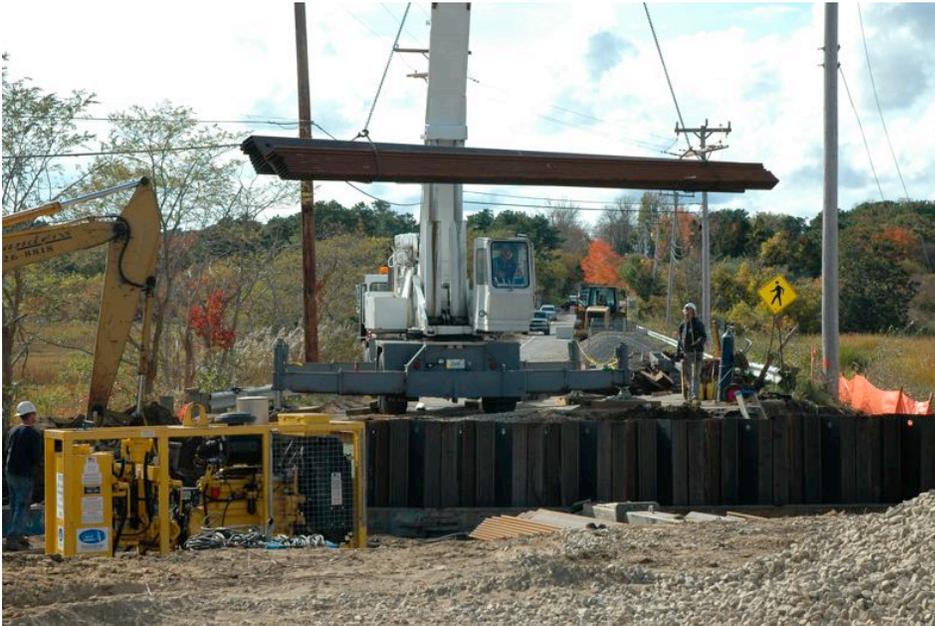
Figure 5. Construction of culvert. The steel sheet piling forms the coffer dam to keep water out during construction. The unrestricted and restricted sides of the marsh are on the right and left sides of the roadway, respectively. Construction was funded by a \$1.6 million grant from NOAA and the American Recovery and Reinvestment Act of 2009 (ARRA).

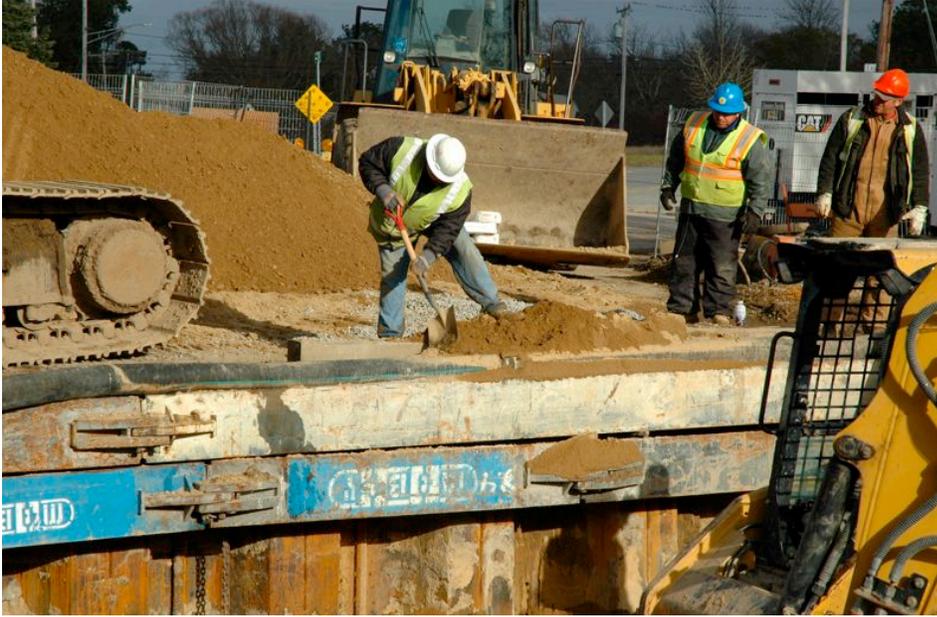
Figure 6. Culvert construction in progress. Culvert construction was done by P A Landers, Inc.

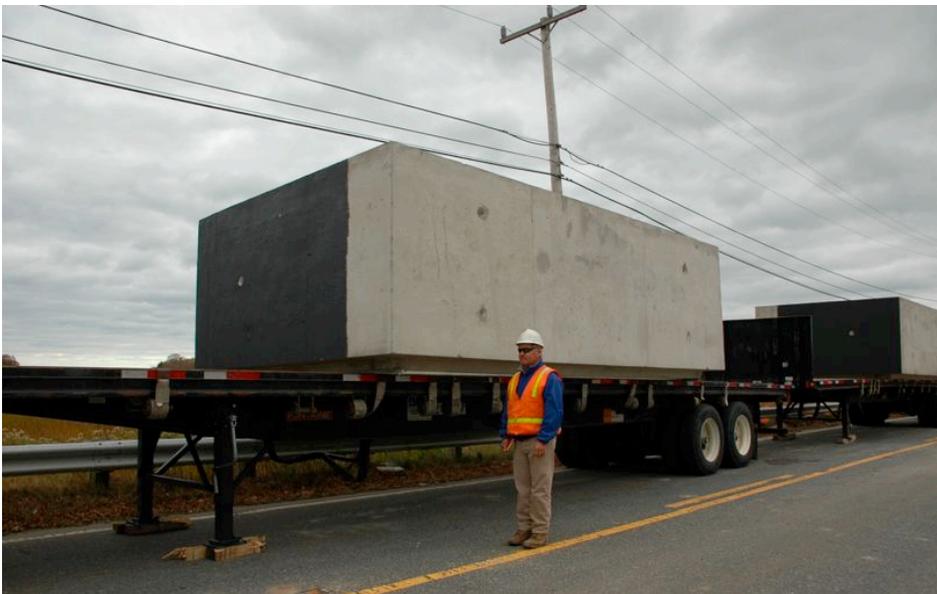
Figure 7. Culvert sections prior to installation. Construction oversight manager Bruce Heben from CLE Engineering, Inc. is in the foreground.

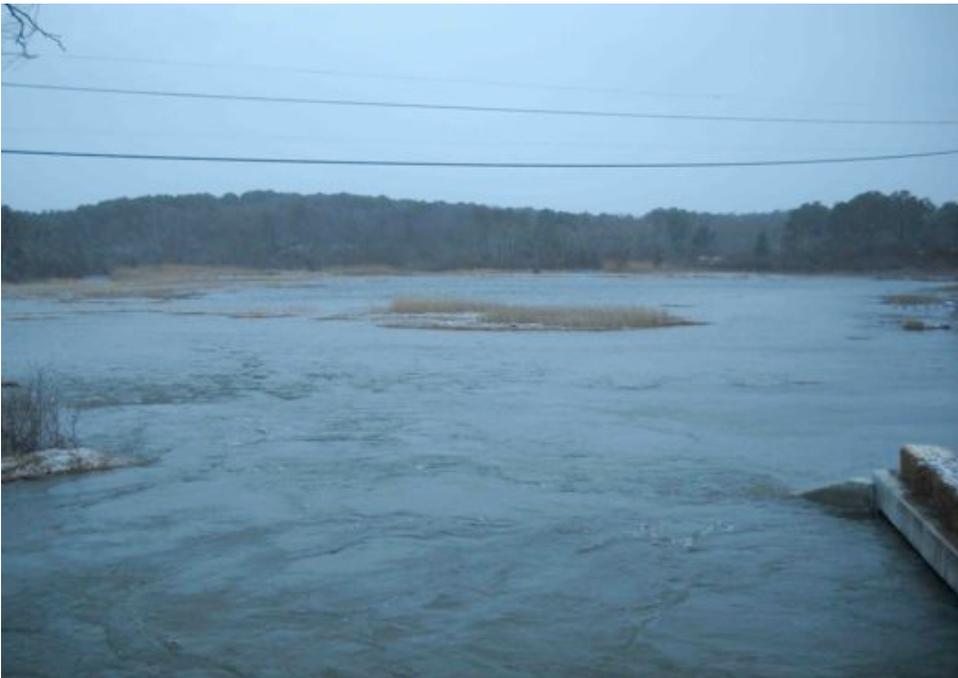
Figure 9. Stony Brook salt marsh following restoration, during a high tide. The south side of the new culvert is visible at the right. The state highway is off the right edge. December 2010.

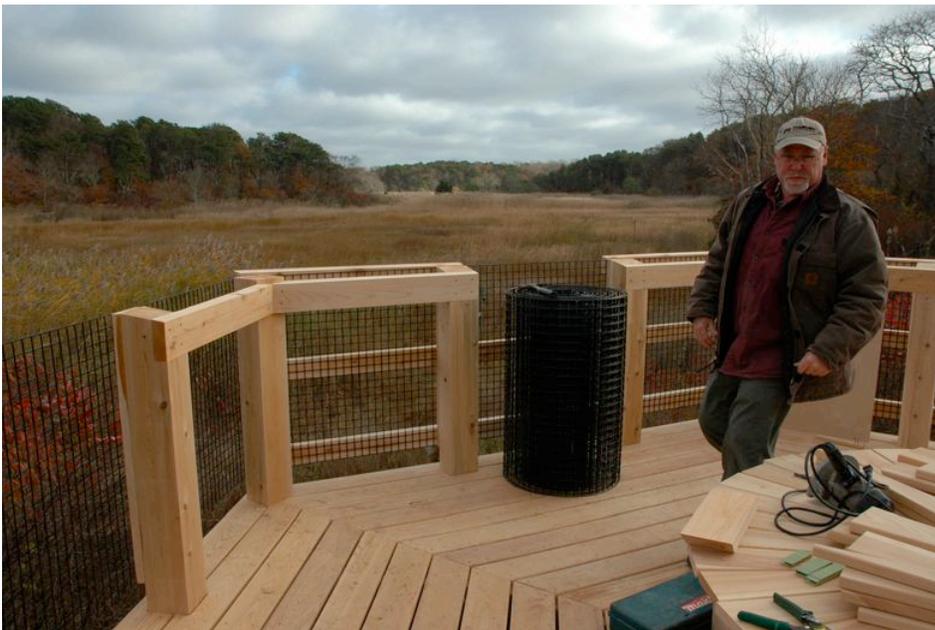
Figure 11. Work on observation platform overlooking the marsh to be restored. Dana Green, of Green & Robinson, Inc. built the platform and trail improvements. November 2010.

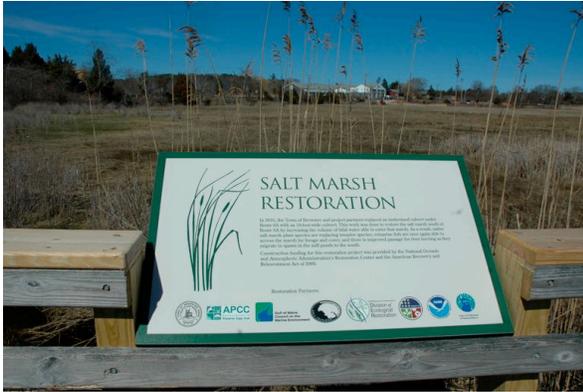
Figure 12. New salt marsh observation platform and trail signage installed as part of Stony Brook salt marsh restoration.
